Clean Water Act Compliance Evaluation Inspection Report

CWA COMPLIANCE EVALUATION INSPECTION REPORT U.S. ENVIRONMENTAL PROTECTION AGENCY, REGION 5

Compliance Evaluation Inspection Purpose: Farms, Inc. Ex. 6 (Personal Privacy) Facility: NPDES Permit Number: WI-0059536 Date of Inspection: April 29, 2014 August 19, 2014 **EPA Representatives:** Donald R. Schwer III, Enforcement Officer Joan Rogers, Environmental Scientist State Representatives: Brad Holtz, Agricultural Runoff Mgmt. Specialist Danielle Block, Agricultural Runoff Mgmt. Specialist Ex. 6 (Personal Privacy Facility Representatives: lice President Nathan Nysse, Consultant Report Prepared by: Donald R. Schwer III, Enforcement Officer

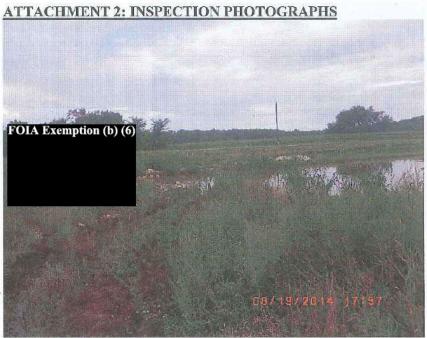
IMGP1351

After the first flush is collected, the process wastewater would flow north into the VTA for the treatment of process wastewater. Process wastewater in the VTA would flow north through the VTA and outlet at the northwest end of VTA into a culvert under Robin Lane (Attachment 2: IMGP1351-IMGP1356). The discharge would flow north to an intermittent unnamed tributary of Casco Creek. The facility was collecting all process wastewater from the silage pad at the time of the inspection.

Description: Water from the vegetated treatment area (VTA) outlets to the north under Robin Lane. Water would continue north to an intermittent unnamed tributary of Casco Creek.

Location: North end of VTA. Camera Direction: North

Although the VTA was not operational during the inspection, the VTA is a system that is designed to treat and discharge wastewater generated on the silage pad. A system that treats and discharges wastewater should be designed to meet the New Source Performance Standards for Dairy Cows and Cattle Other Than Veal Calves (40 CFR 412.35).

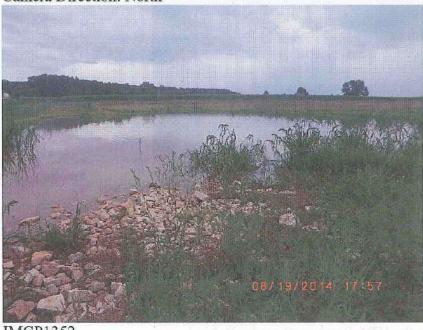
IMGP1352

Description: Water in the VTA. Location: North end of VTA. Camera Direction: East

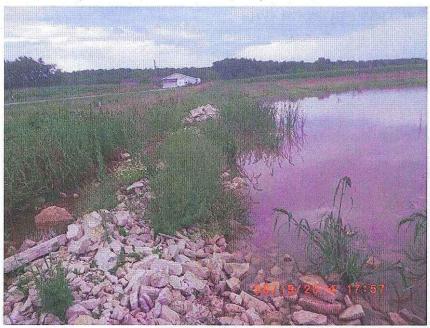
IMGP1353

Description: Water in the VTA. Location: North end of VTA. Camera Direction: East

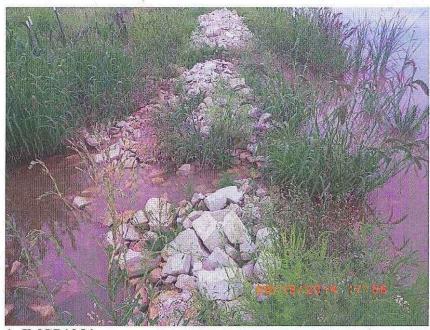
1: IMGP1354

Description: Water from the VTA flows north under Robin Lane.

Location: North end of VTA. Camera Direction: Down/East

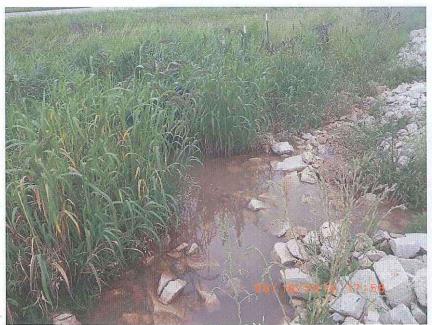
2: IMGP1355

Description: Water from the VTA flows north under Robin Lane.

Location: North end of VTA. Camera Direction: Down/East

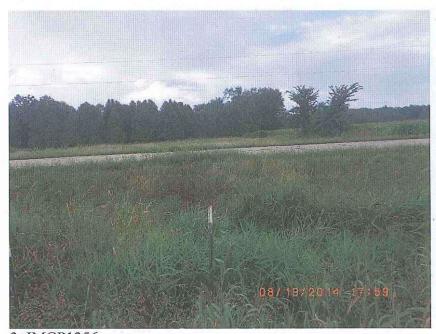
3: IMGP1356

Description: Water from the VTA flows north under Robin Lane.

Location: North end of VTA. Camera Direction: North

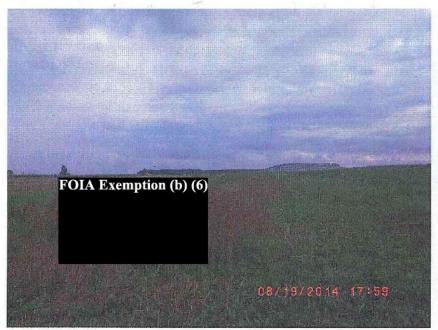
4: IMGP1357

Description: Area west of VTA.

Location: West of VTA Camera Direction: South

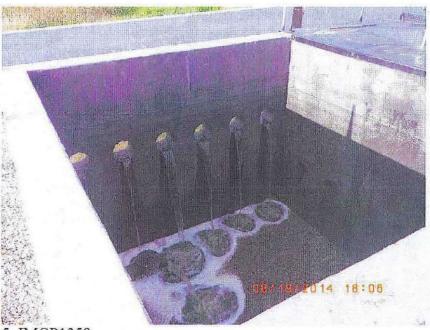
5: IMGP1358

Description: Collection pit for wastewater generated on the silage pad.

Location: South end of VTA. Camera Direction: Down

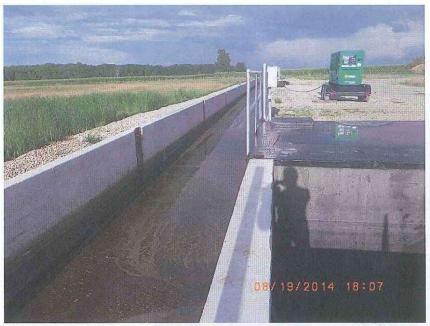
6: IMGP1359

Description: The concrete structure spreads out wastewater along the length of the VTA.

The outlet structures were closed during the inspection.

Location: South end of VTA Camera Direction: East

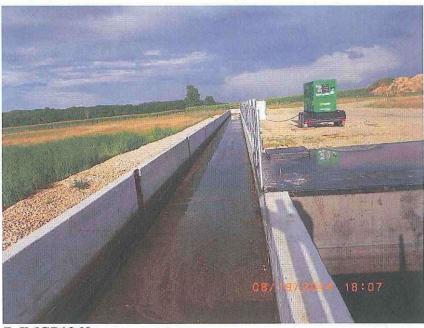
7: IMGP1360

Description: The concrete structure spreads out wastewater along the length of the VTA.

The outlet structures were closed during the inspection.

Location: South end of VTA Camera Direction: East

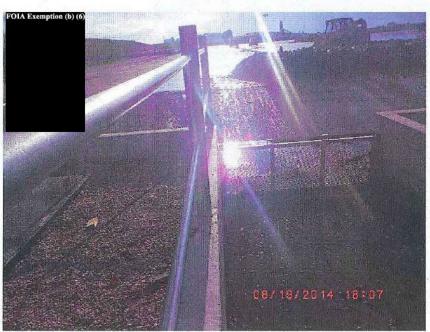
8: IMGP1361
Description: Inlet into the spreader and collection structures.
Location: South end of VTA

Camera Direction: West
